DRONE/UAS

Edition 8
August 2023

Report No1: DUAS XX10 – Probable Battery Disconnection Source: AAIB Bulletin: 6/2023 DJI Mavic 2 Enterprise AAIB-28582

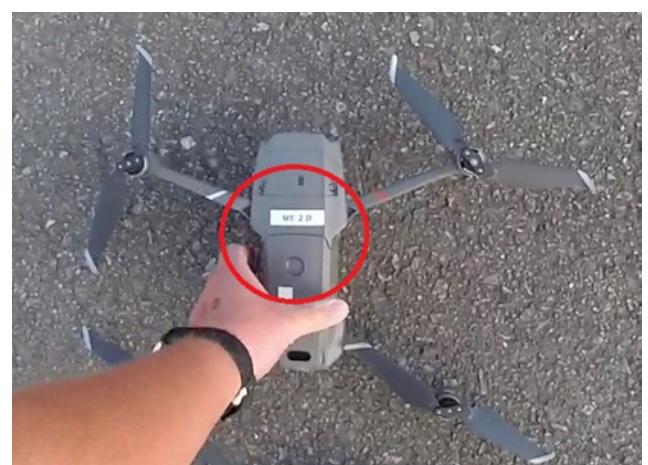
Recorded data indicated that the battery probably disconnected in flight. This could have been caused by

the battery not having been fully latched prior to take-off, or the latching mechanism or battery being worn from repeated use, resulting in an in-flight disconnection. The operator has taken safety action to remind their pilots of the importance of pre-flight checks and checking airframe and battery condition at their base.

The recorded data indicates that the most likely cause was a loss of battery power to the aircraft which instantly cut off the motors and the link to the controller. The battery state of charge was 77% at the time and there had been no warnings related to the battery. Both the operator and the aircraft manufacturer concluded that the most likely cause was the battery becoming disconnected. The damage to the battery was consistent with it having separated when the aircraft struck the roof of the building, and this detachment was more likely if it was already loose.

The operator believed that the pre-flight checks were probably rushed and that the body worn camera image showed the battery not fully engaged (see photo). The aircraft manufacturer could not confirm whether it was fully engaged, but it is possible that it was not. It is also possible that the battery was engaged at that time, but that the latching mechanism or battery were slightly worn from use which led to an in-flight disconnection. There was no indication that the battery was swollen or had exceeded the temperature limit.

The operator has shared the learning from this accident with all its UAS pilots and reminded them of their responsibility to turn on their body worn camera before they carry out the UAS pre-flight checks so that the checks are captured, and of their responsibility to take time on the UAS checks that are completed at a local air base to ensure the aircraft is fit for use. They also planned to reinforce the briefing of observers, and to carry out routine checks of the batteries.

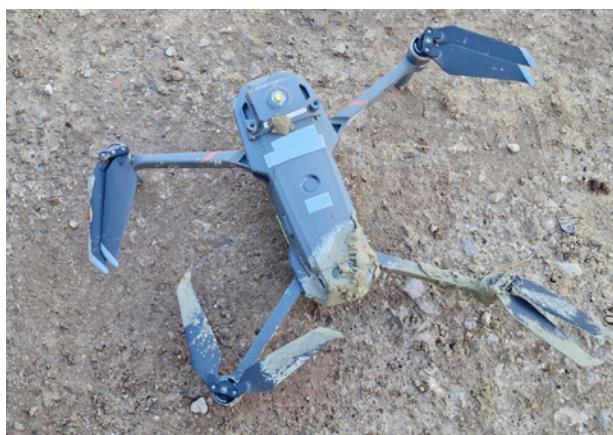
Report Text: During an aerial survey flight, the UAS detected a rapid loss of battery power and initiated an immediate automatic landing. Whilst descending, its flight behaviour became erratic, control was lost to the remote pilot, and the UA struck an uninvolved person before hitting the ground. The photograph shows the UA after falling to the ground.

During flight, the battery percentage detected by the UAS dropped at an unexpectedly high rate that resulted in an automatic landing without notifying the pilot at the pre-set charge thresholds. The first indication of an abnormal battery discharge rate was during flight control checks. The pilot chose to continue with the planned flight as it would have been achievable using the indicated 88% battery level. Subsequently, the UAS continued to detect a high discharge rate which triggered the automatic landing. After the flight the battery integral charge level indicator showed 50-75% charge. It was not possible to determine the difference between this charge level and the battery power displayed on the handheld controller during the flight. Flight log data did not explain the discrepancy in battery level.

The UAS measured a high loss of battery power in a short space of time, leading to an uncontrolled landing where the distance between the UA and uninvolved people and structures was compromised. This sequence of events resulted in the UA striking an uninvolved person. It was not possible to determine a cause of the UA's detecting a loss of battery power or its flight behaviour. Whilst the displayed level of power remaining was sufficient for the planned flight, there may have been an opportunity during flight control checks for the pilot to consider the abnormal battery discharge rate was likely to continue, and to abort the flight.

CHIRP Comment: Warnings during pre-flight control checks should always be heeded. Not everything is explained in the user manual of these type of aircraft, so a warning that comes up on the controller, which is then countered by other indications, deserves a landing followed by careful consideration. The software sometimes includes in-built triggers that are not fully explained, perhaps because they were part of an update instigated after the manual was published.
