Design, build and operations

Always expect the unexpected

Welcome to Drone FEEDBACK Edition 11. The weather has not been very helpful to Drone flying since we published Edition 10 in April. We have now passed midsummer day and are hoping for rather more stable conditions for late summer and early autumn. The wind has been somewhat troublesome during this period and showers have resulted in stop-start scenarios with the potential consequences manifesting themselves at the image processing stage, long after the Operator has left the site. All of this results in the potential for Human Factor risks coming from a different direction, when

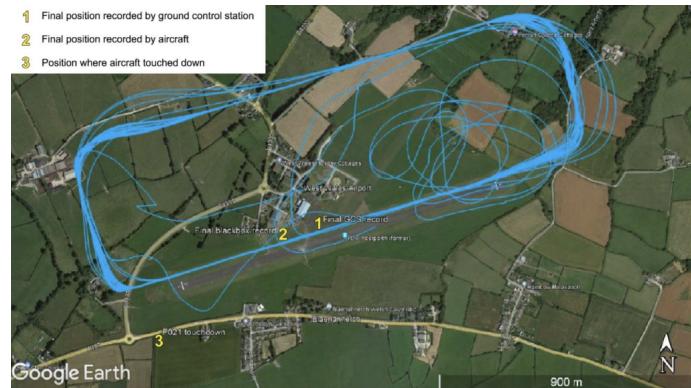
A number of tests were conducted to validate the autopilot and flight control systems. At 1350hrs the RP observed that the engine had stopped, with the aircraft 1,000ft agl over the centre of the airfield and routing along the northern edge of Runway 25. He informed the RPSO that he was taking control by saying "my bird" to which the RPSO acknowledged "your bird". However, the RP then advised the RPSO that he was not able to gain control; the RPSO then attempted to regain control but without success. The RPSO advised ATC of the situation. Meanwhile, the aircraft continued further along the direction of Runway 25 for about 30secs before turning right and circling, then disappearing from the RP's sight beyond a hedge (see graphic of the track during the accident flight).

Operator investigation: The operator's post-flight investigation determined the accident occurred because of the total loss of electrical power. This occurred on the second flight of the day once the emergency battery became discharged, resulting in loss of flight control, communication with both the RP and the RPSO and the shutdown of the engine. Consequently, the aircraft glided to the point it touched down.

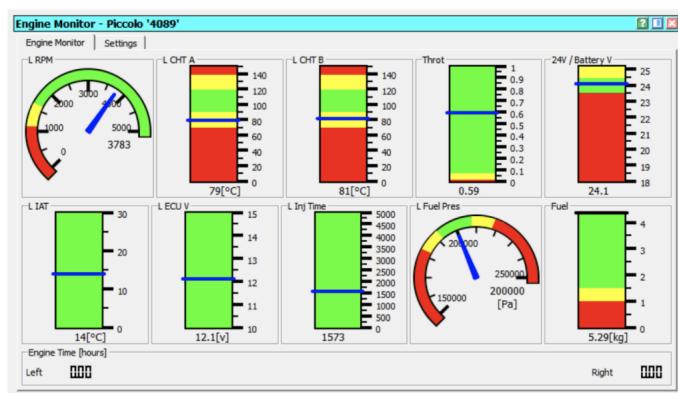
The operator identified that the after-flight check list was missing a check of the emergency battery status prior to the aircraft being connected to the ground power. It also improved the engine monitoring graphical interface flight telemetry system to include voltage indication of the emergency battery to allow its charge status to be monitored in flight (updated engine monitor page shown with new emergency battery voltage indication top right). This would indicate if the alternator generator system was faulty.

Whilst it is easy to see that the emergency battery is charging properly in the second graphic (post the manufacturer's reconfiguration of the controller display), it is interesting to note that the design of the aircraft originally meant that the wiring layout of each aircraft was unique. This no doubt resulted in quality control of the wiring during manufacture being a difficult and time-consuming process, prone to error.
